MEWBOURNE
COLLEGE OF EARTH & ENERGY
THE UNIVERSITY OF OKLAHOMA

The broken traffic light: the troubles with a stale yellow light

Austin Holland and Amberlee Darold,
Oklahoma Geological Survey

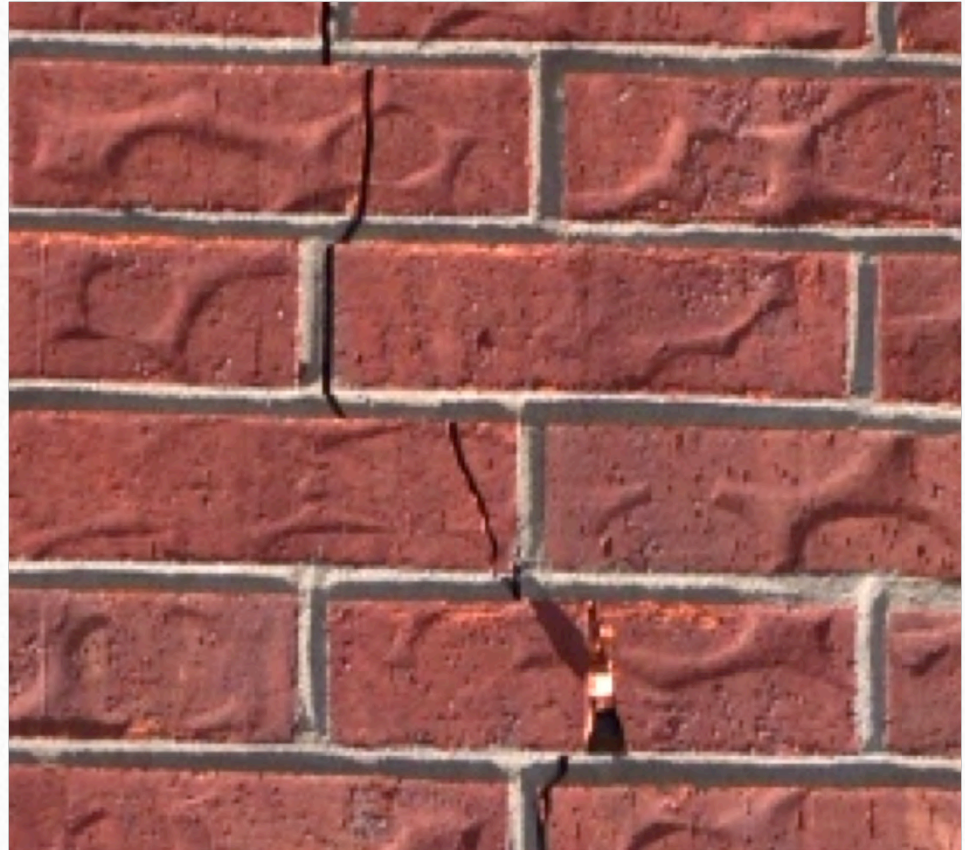
Damage summary from the magnitude 3.4 Sep. 23, 2013

Damage to Homes

- Collapsed Chimney (1)
- Shattered Window (1)
- Damaged brick façade (~5)
- Doors and frames crooked (~5)
- Cracked foundations
 - Difficult to distinguish from normal OK soil effects
- Cracked drywall and cosmetic damage (~15-20)
- Fallen objects and strong shaking (>20)

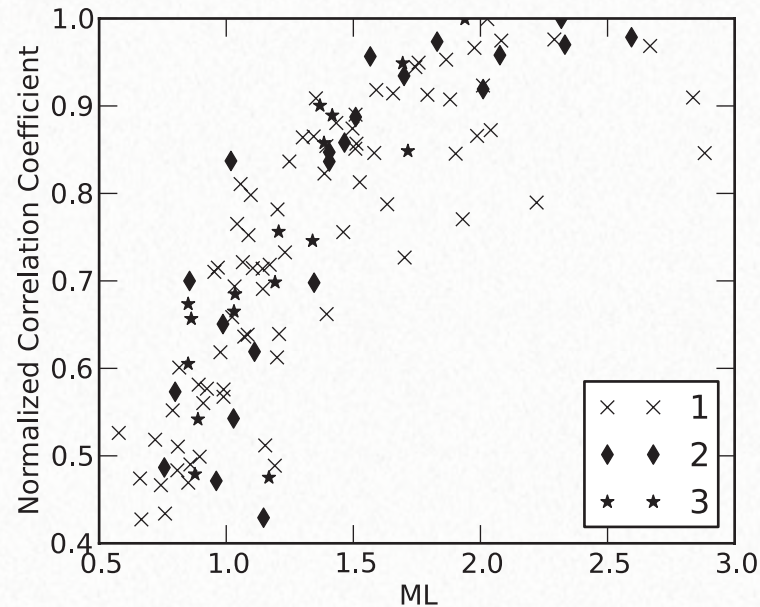
Event identification using cross-correlation

Template

xcor 0.999343, amp 410.348065

xcor 0.974703, amp 355.221352

xcor 0.880522, amp 88.658416

xcor 0.532448, amp 300.184191

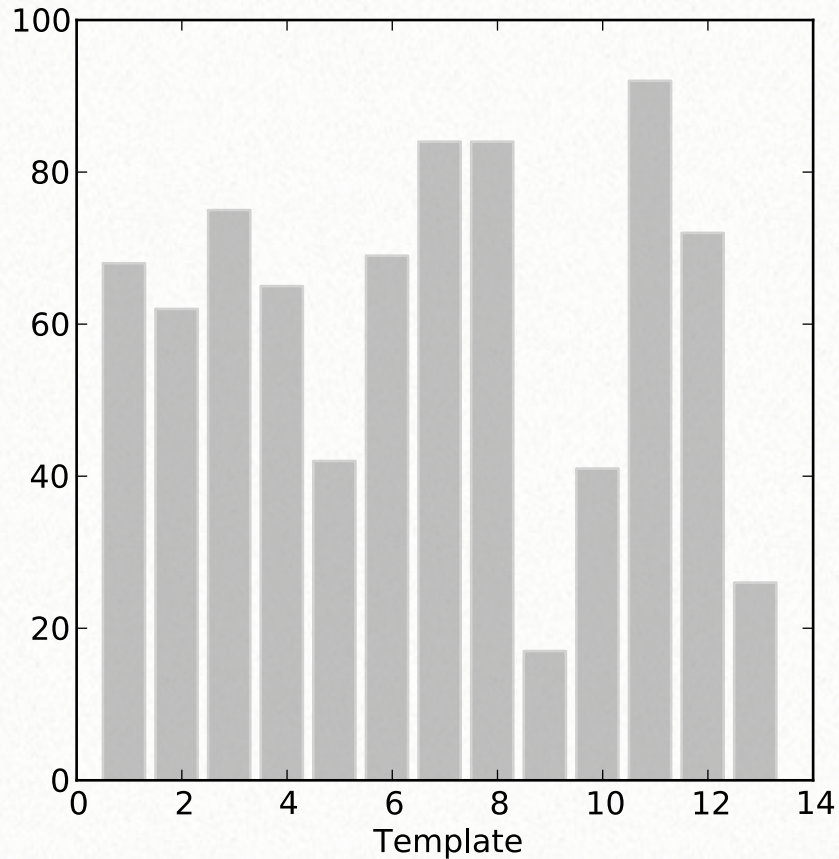
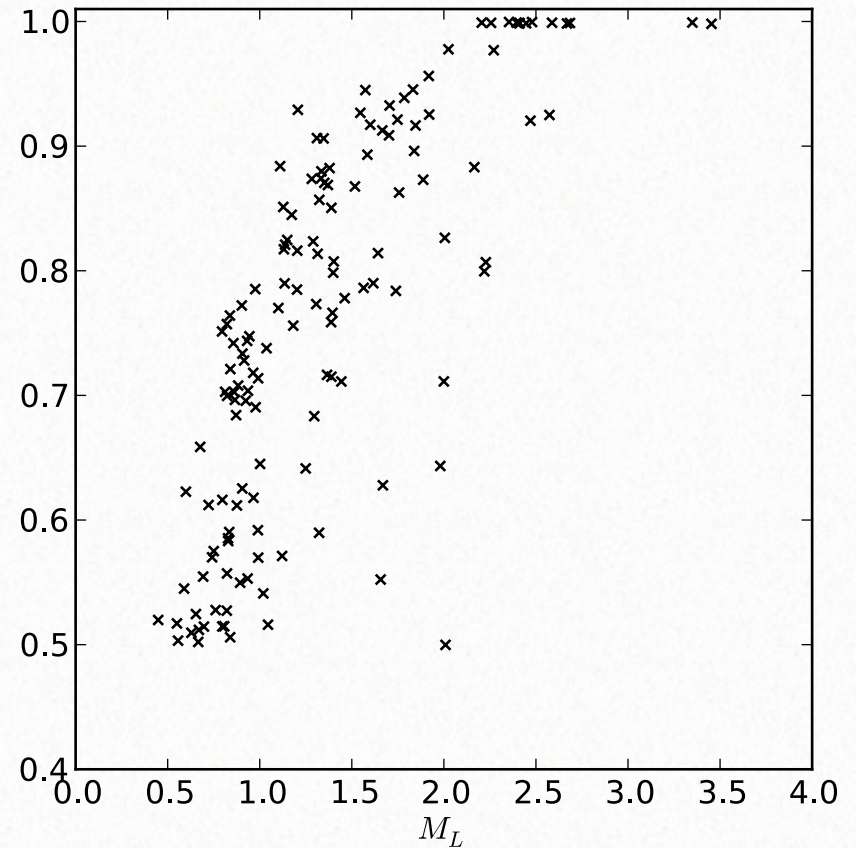
Cross-Correlations for Love County

142 Unique Events Identified through cross-correlation
Using station WMOK

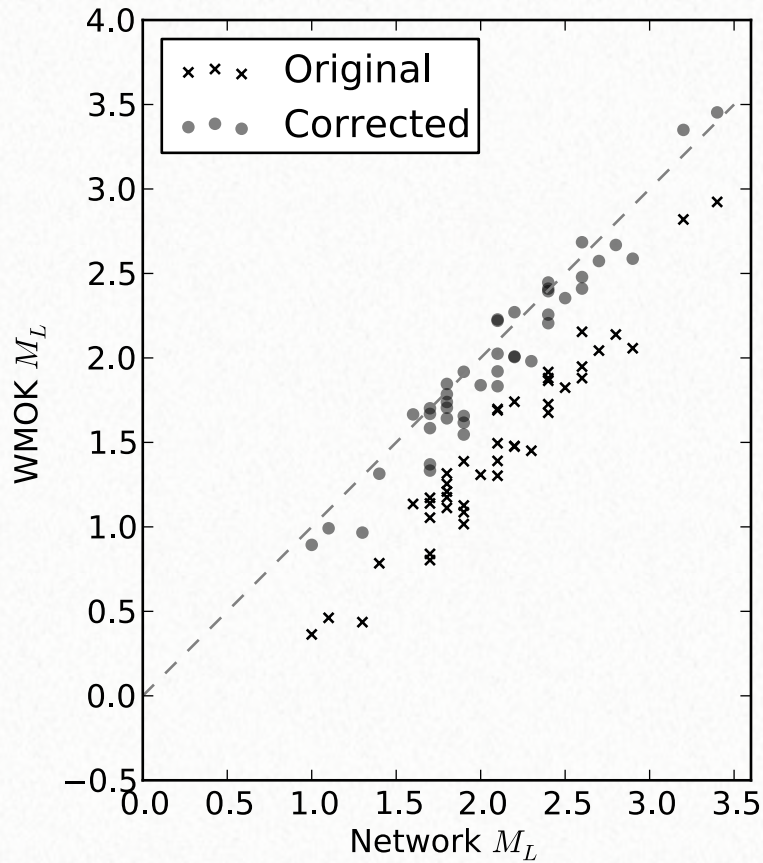
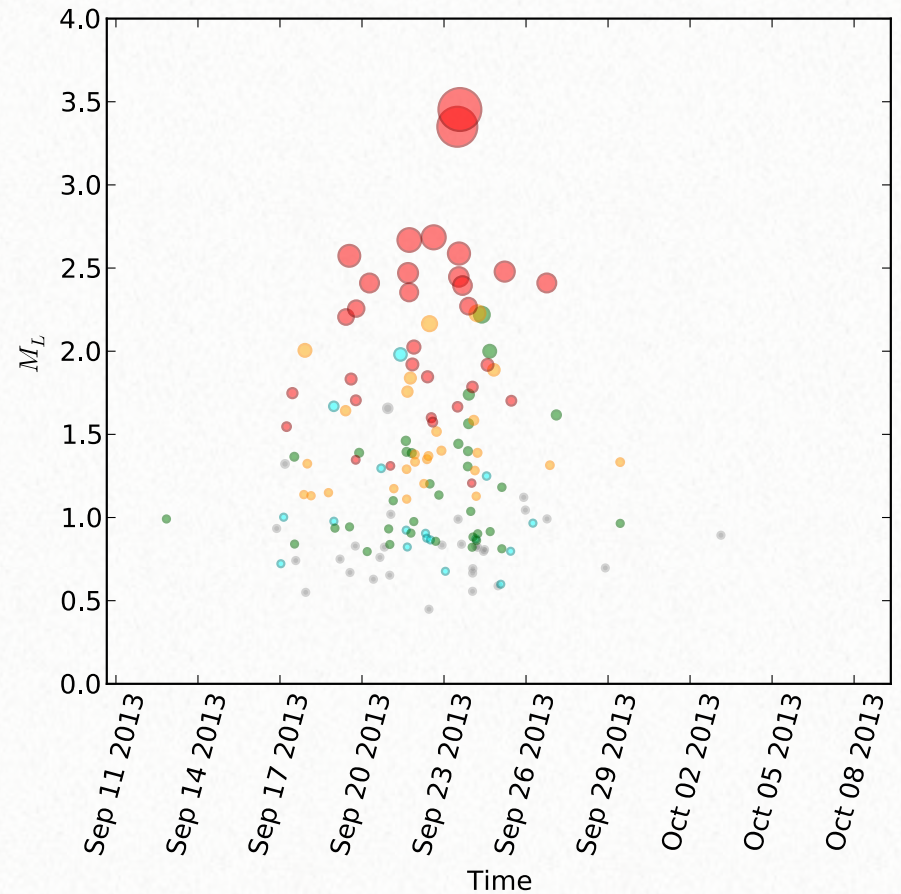
Magnitude Calculations for Love County

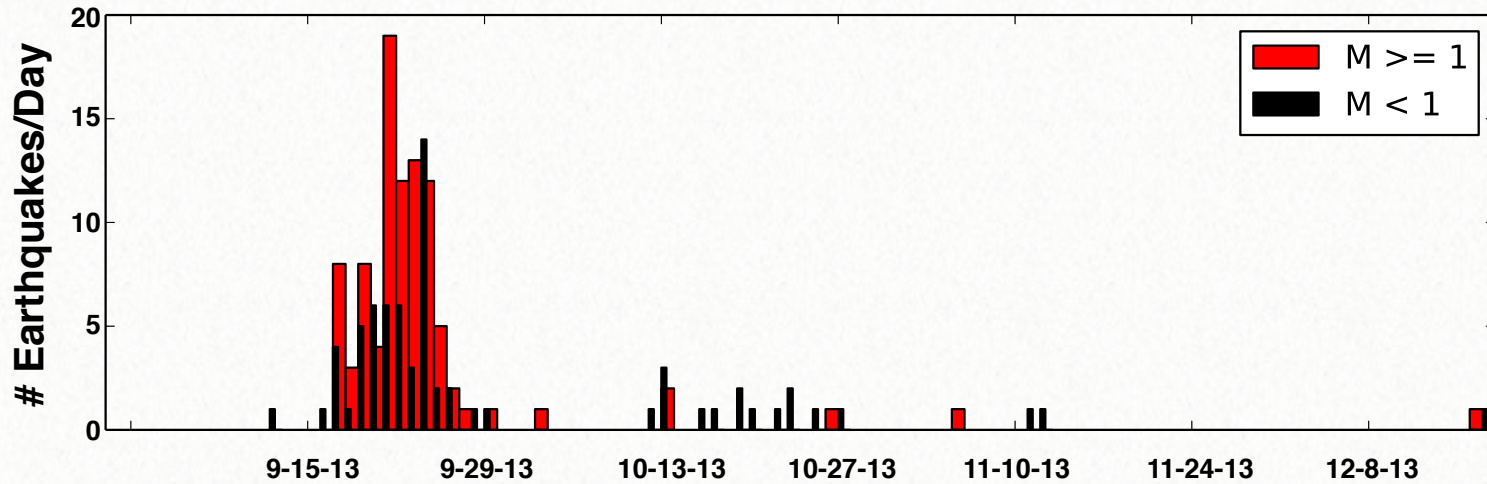
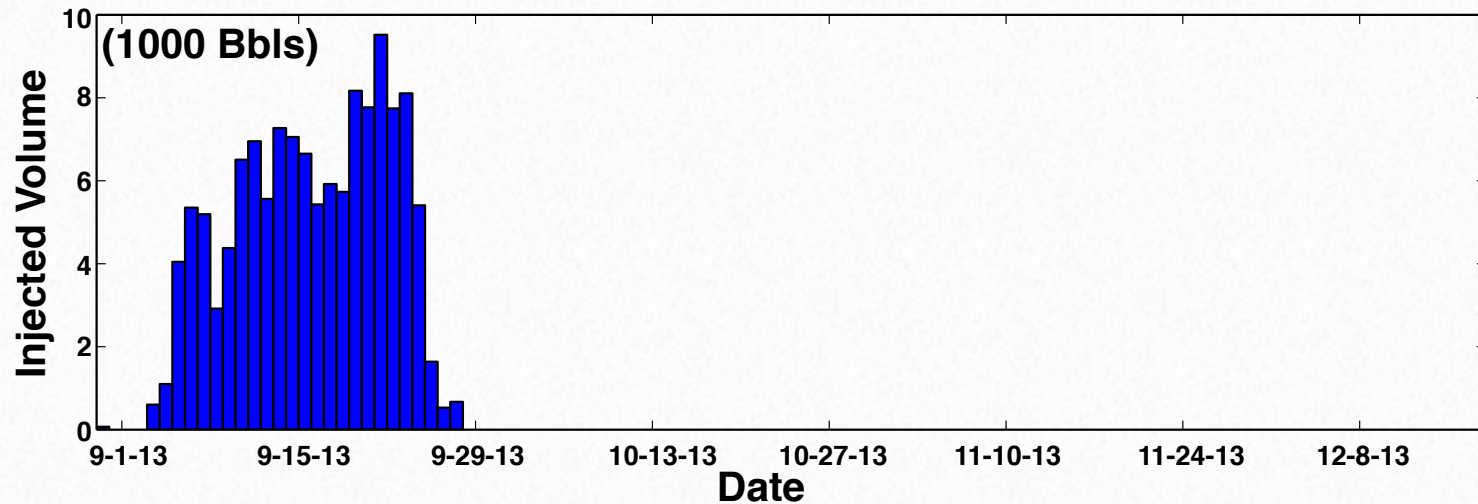
LCD #1 Injection and Earthquakes

Rate of earthquakes much greater during injection

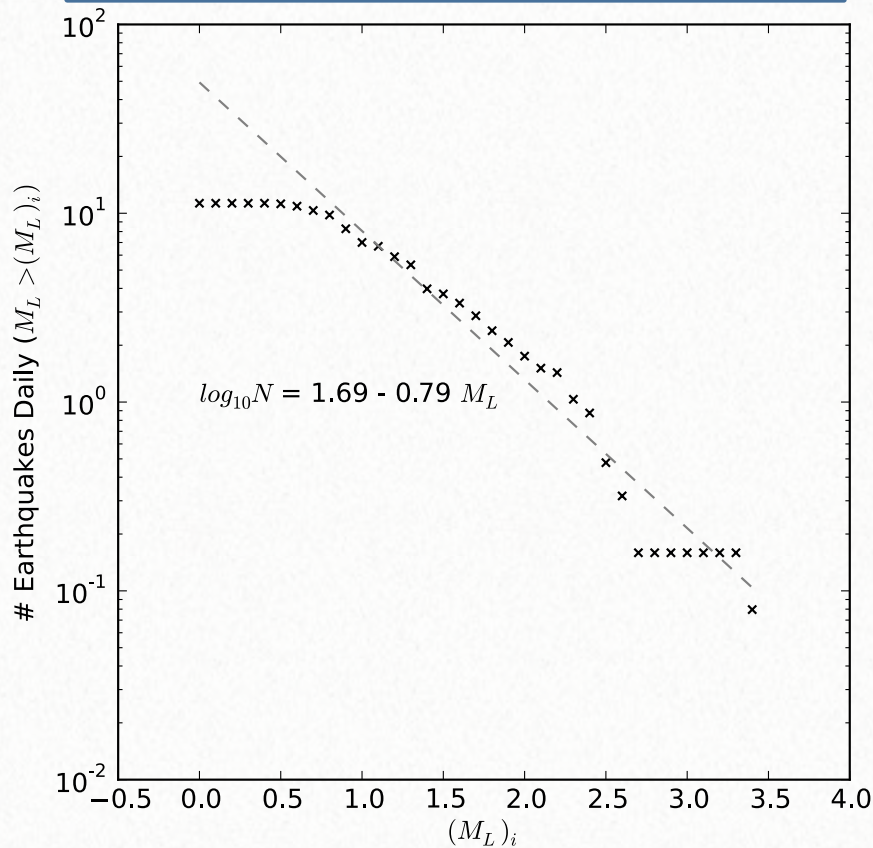
WMOK Cross Correlations

Events from: 9/16 - 9/29/13

Magnitude of Completeness: $M_c \sim 1.0$

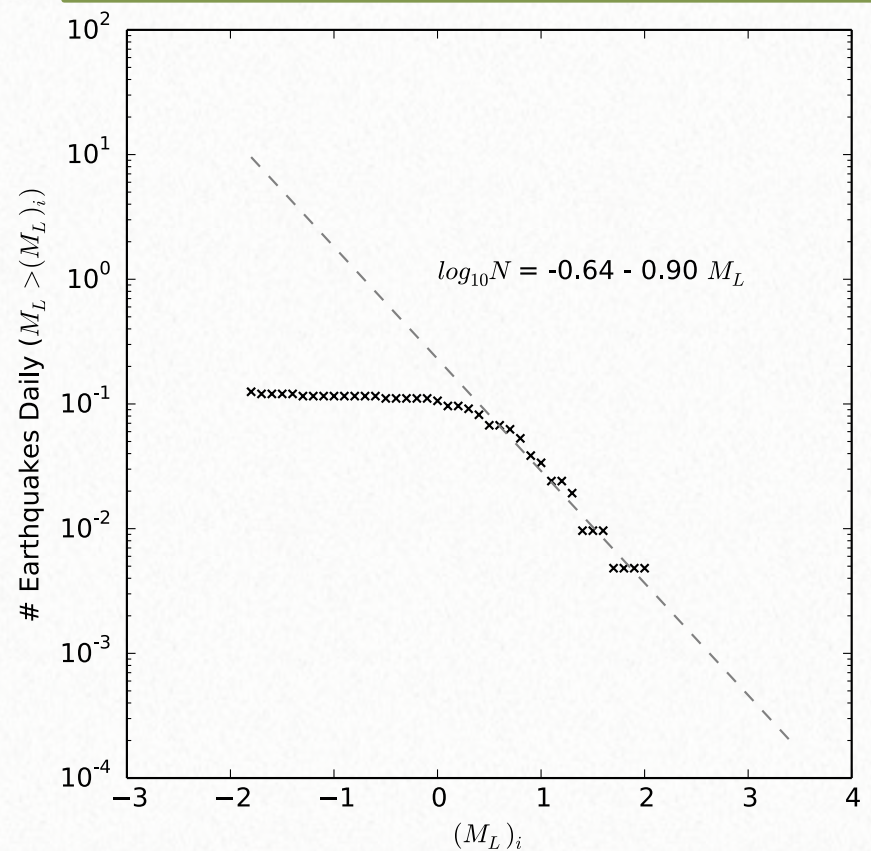
Earthquakes located using local network

Events from: 9/29 - 4/25/14

Magnitude of Completeness: $M_c \sim 0.5$

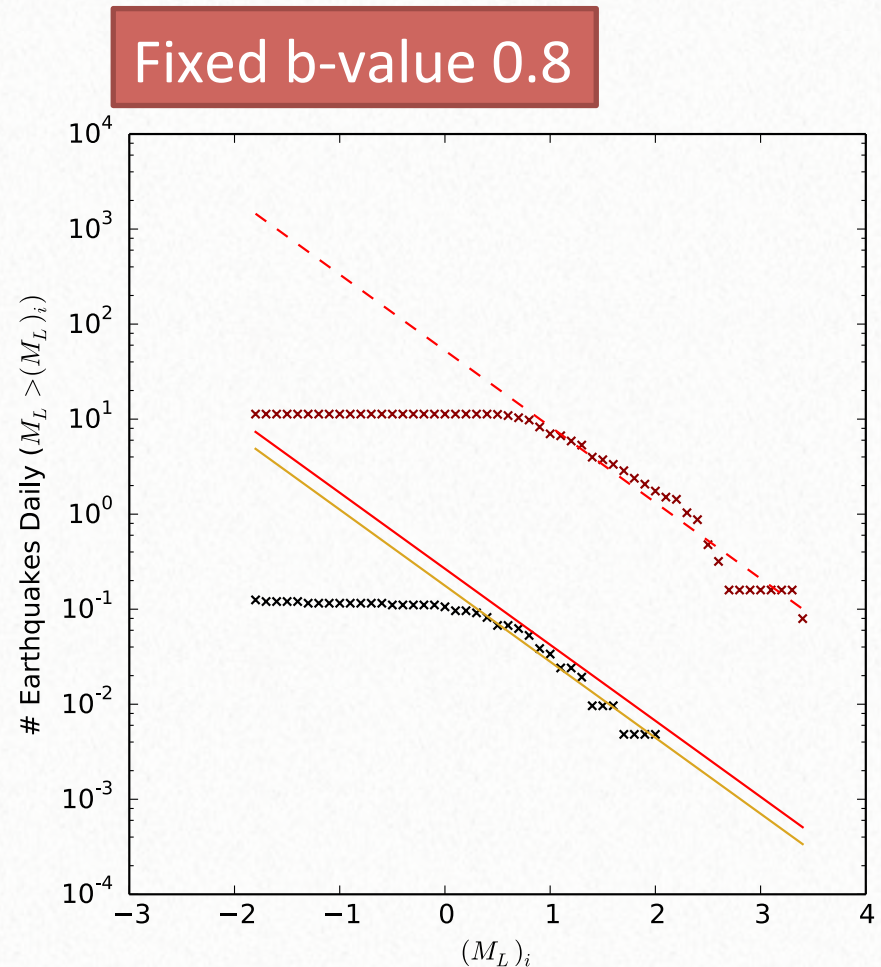
Probability of at least one M magnitude or greater in 60 days

a	% Prob M 1.8	% Prob M 2.5
Background	-0.7522	38.41	10.6
2σ – 95% CI	-0.5743	57.78	15.97
Injection	1.722	100	100

- Significant probability of a M 1.8 earthquake during yellow light condition.
- A magnitude 2.0 occurred within the study area within the 60 days from calculating these
